Assessment of Irrigation Performance in Başören Irrigation Cooperative Area of Beypazarı, Ankara

Abstract: This research has been carried out to assess the irrigation performance of the year 2015 in Ankara Beypazarı Başören Irrigation Cooperative, where the irrigation is made by ground water. With this aim, performance indicators related to water utilization efficiency, agricultural efficiency, social and economic efficiency were determined in the research area.

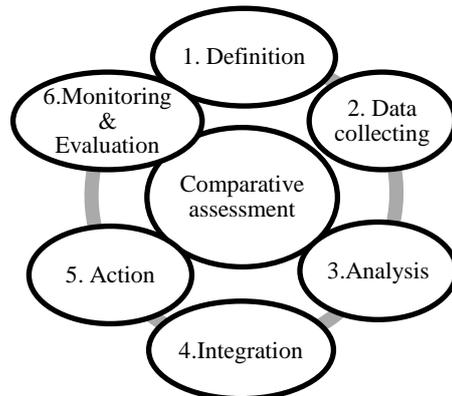
Figure 2. Phases of comparative assessment process (Malano and Burton 2001)

Irrigation performance of Başören irrigation cooperative was determined by comparative indicators (Malano and Burton 2001). The stage

of comparative assessment is given in Figure 2. The performance indicators and relevant data used in this study are provided in Table 2.
